SUBJECT: Site Inspection, Quality Building Stone, Unpermitted Quarries,
M/055/022, Wayne County, Utah

Date of Inspection: March 18, 2004
Time of Inspection: About 12:00 to 2:00 and 5:00 to 6:30 PM
Conditions: Mostly sunny, 60's
Participants: Wes Hansen and Dan Powell, Quality Building Stone; Buzz Rakow, Hanksville BLM; Paul Baker, DOGM

M/055/022, Quality Building Stone, Unpermitted Quarry
Inspection Dated: March 18, 2004; Report Dated: March 26, 2004

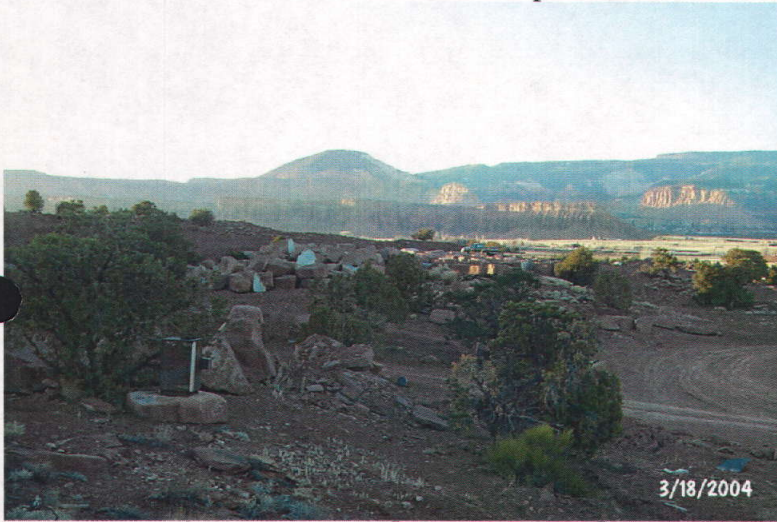
I used the GPS to measure the area of this site in two pieces. The larger area on the attached map is relatively flat and consists of roads and scattered areas of disturbance from storing and loading sandstone blocks. Some of this disturbed area has no more disturbance than tracks or grouzer marks and would be very easy to reclaim, but most of it continues to be used for storing and loading stone. Some views of this area are in Photos 1 through 3.

Photo 1. Part of the storage and loading area.

The operator has indicated a willingness to reclaim part of the disturbed areas to reduce the amount of bond that would be required. A lot of the storage and loading area at the north quarry could be easily reclaimed. There are portions of the south quarry and loading area to the south that could also be reclaimed. The best time to do this would be in the fall although the operator should do any basic grading as soon as possible.

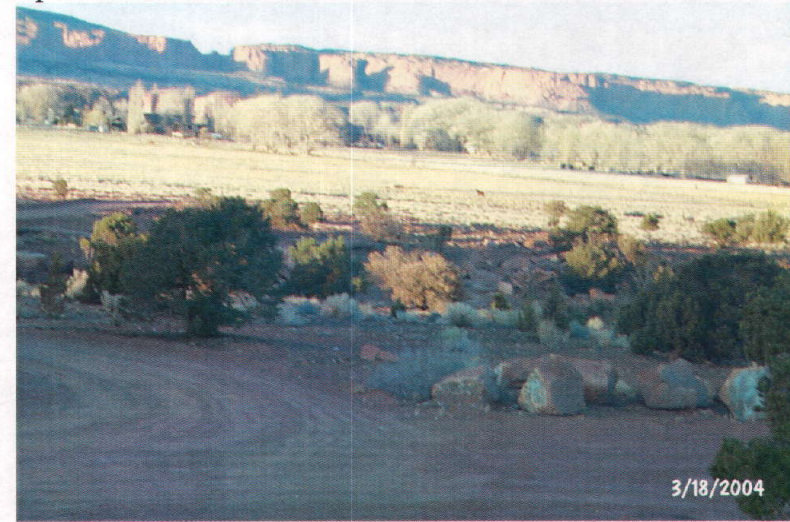
Photo 3. One more view of the storage and loading area. This is just to the east (right) of Photo 2.

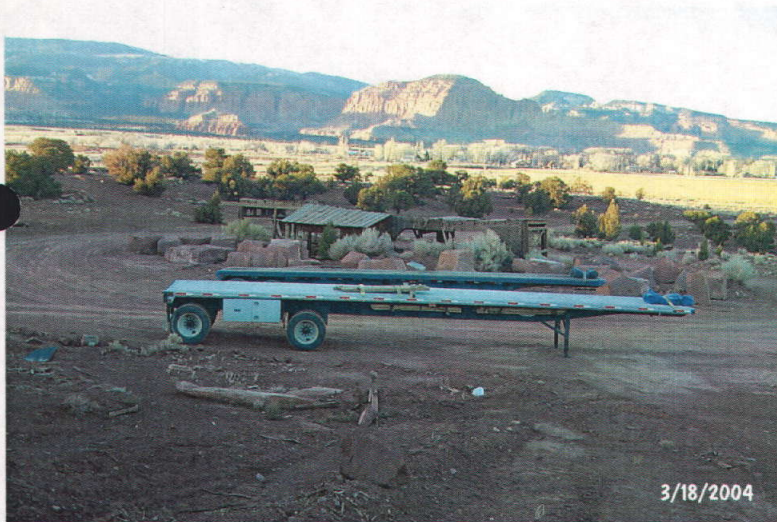
Photo 2 shows an old sawmill. I excluded this area from my GPS measurements but did not exclude any other areas. The perimeter of the loading and storage area is convoluted, but there were no other undisturbed areas within the disturbed area.

Photo 2. Another view of the storage and loading area. The old sawmill is in the center of the pictures.

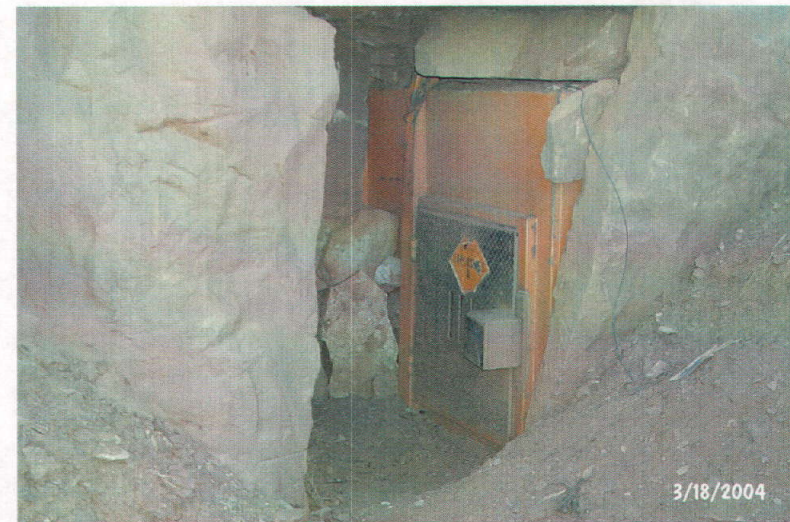
On the south side of this area was a powder magazine shown in Photo 4. It was locked and appeared to have a ground wire.

Photo 4. The powder magazine.

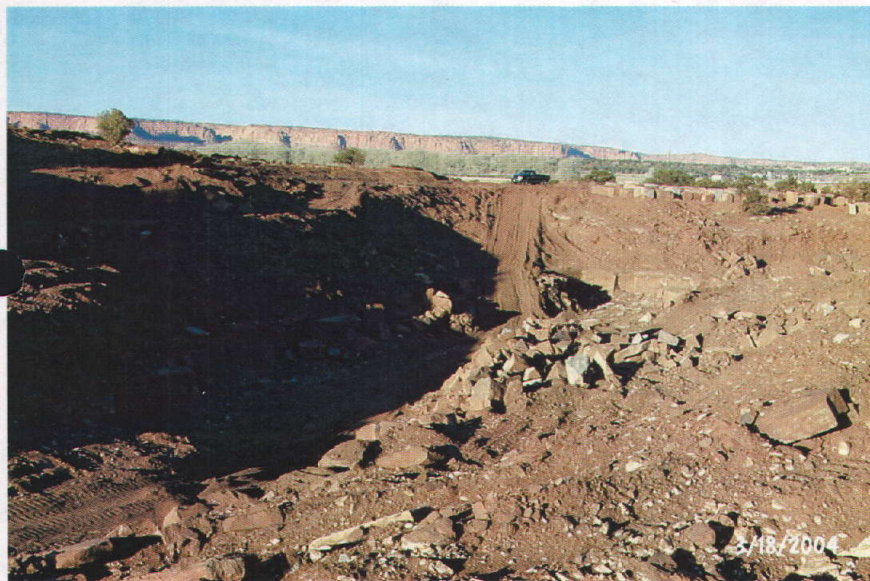
The pit or quarry itself is on the southwest side of the disturbed area. Photos 5 and 7 show the pit. Photo 7 is a panorama of two pictures. I did not attempt to measure the overburden depth, but I would guess the stone being mined is under about 20-30 feet of material.

Photo 5. The quarry looking toward the northeast.

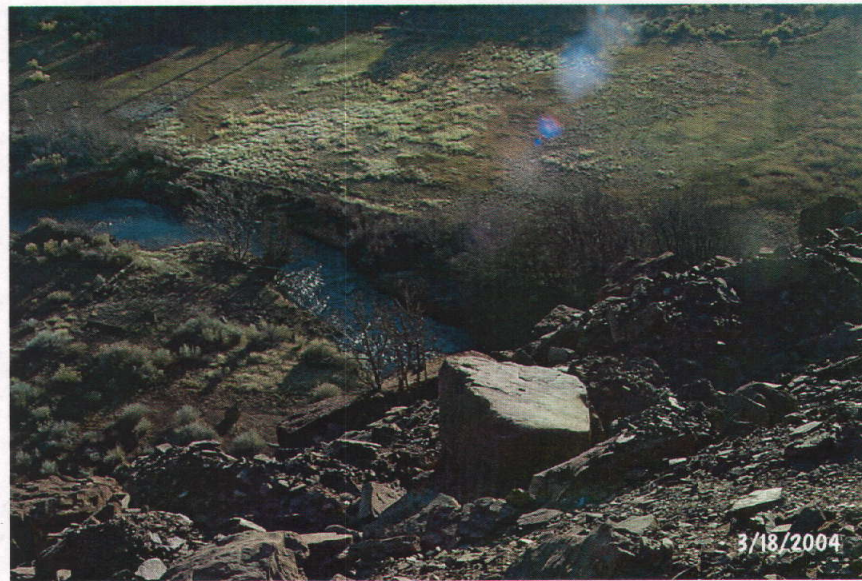
On the south side of the pit, waste material has been graded to the south toward the Fremont River. On the east side, the waste forms a slope extending to the flat alluvial terrace below (Photo 8), but on the west, it goes just down to the top of a cliff, at least as far as I could see (Photo 6).

While I could see that a lot of rocks had rolled to the bottom of the slope where waste extended to the valley floor, I could not see the base of the

cliff. It is likely some waste has fallen from the cliff to the base. During the next inspection, it would be good to go to this area and see exactly how much disturbance there is.

Photo 6. View from the top of the overburden pile toward the Fremont River. This slope ends at a cliff.

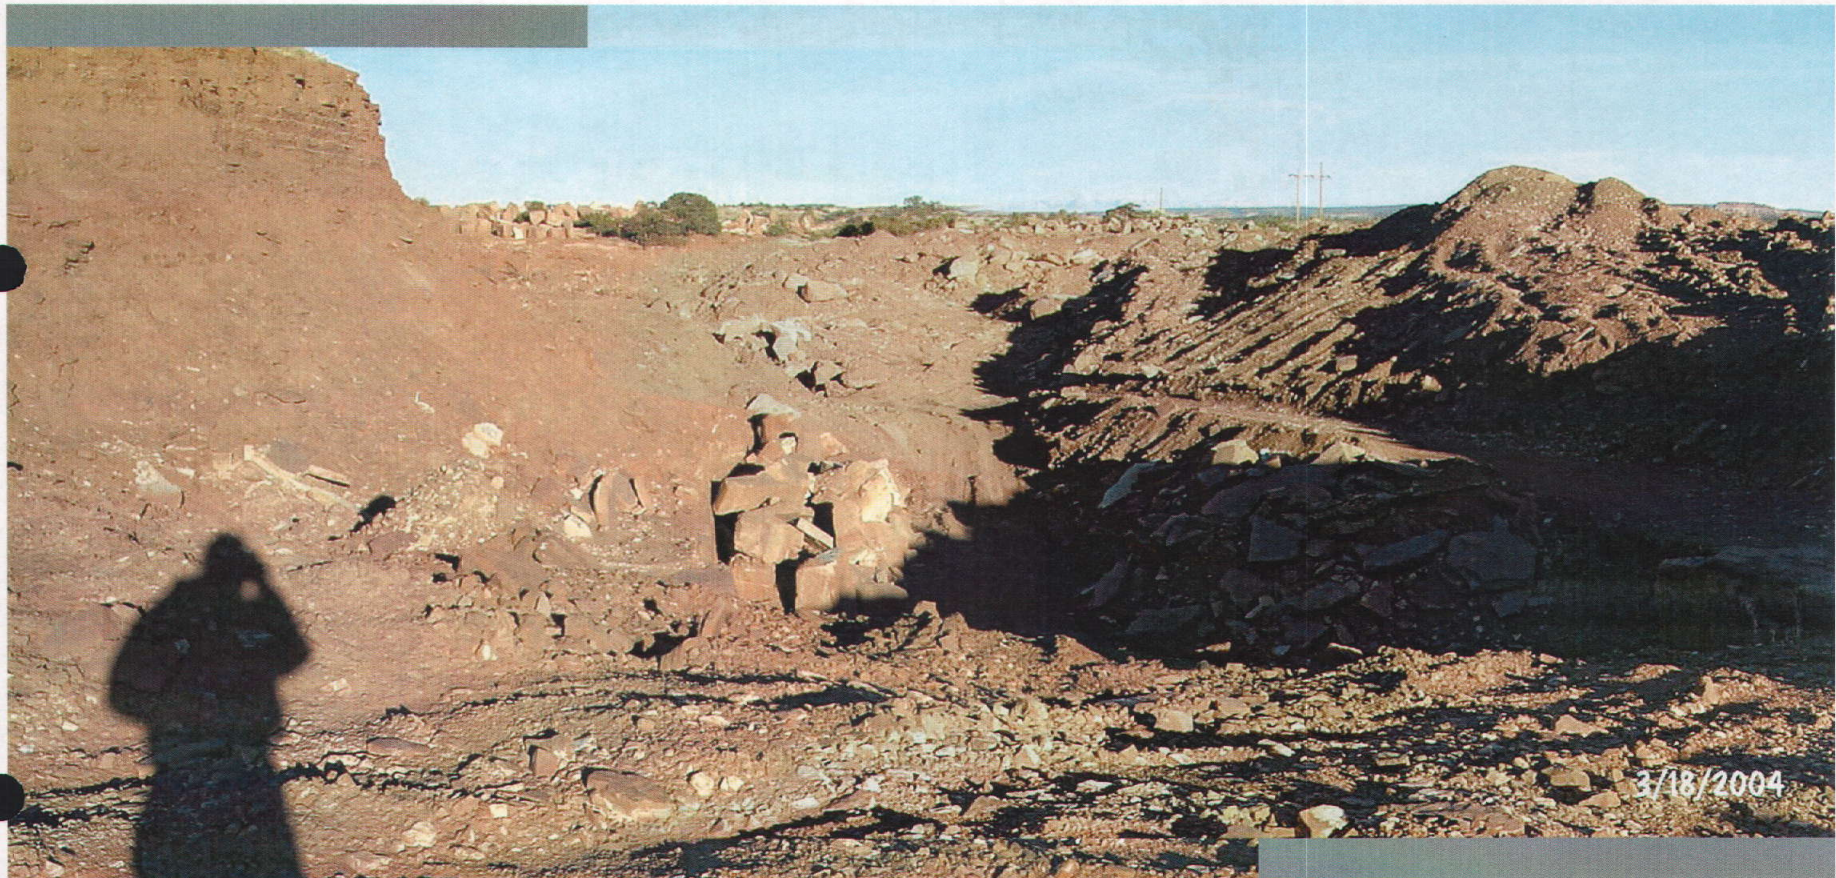
Photo 7. Another view of the quarry.

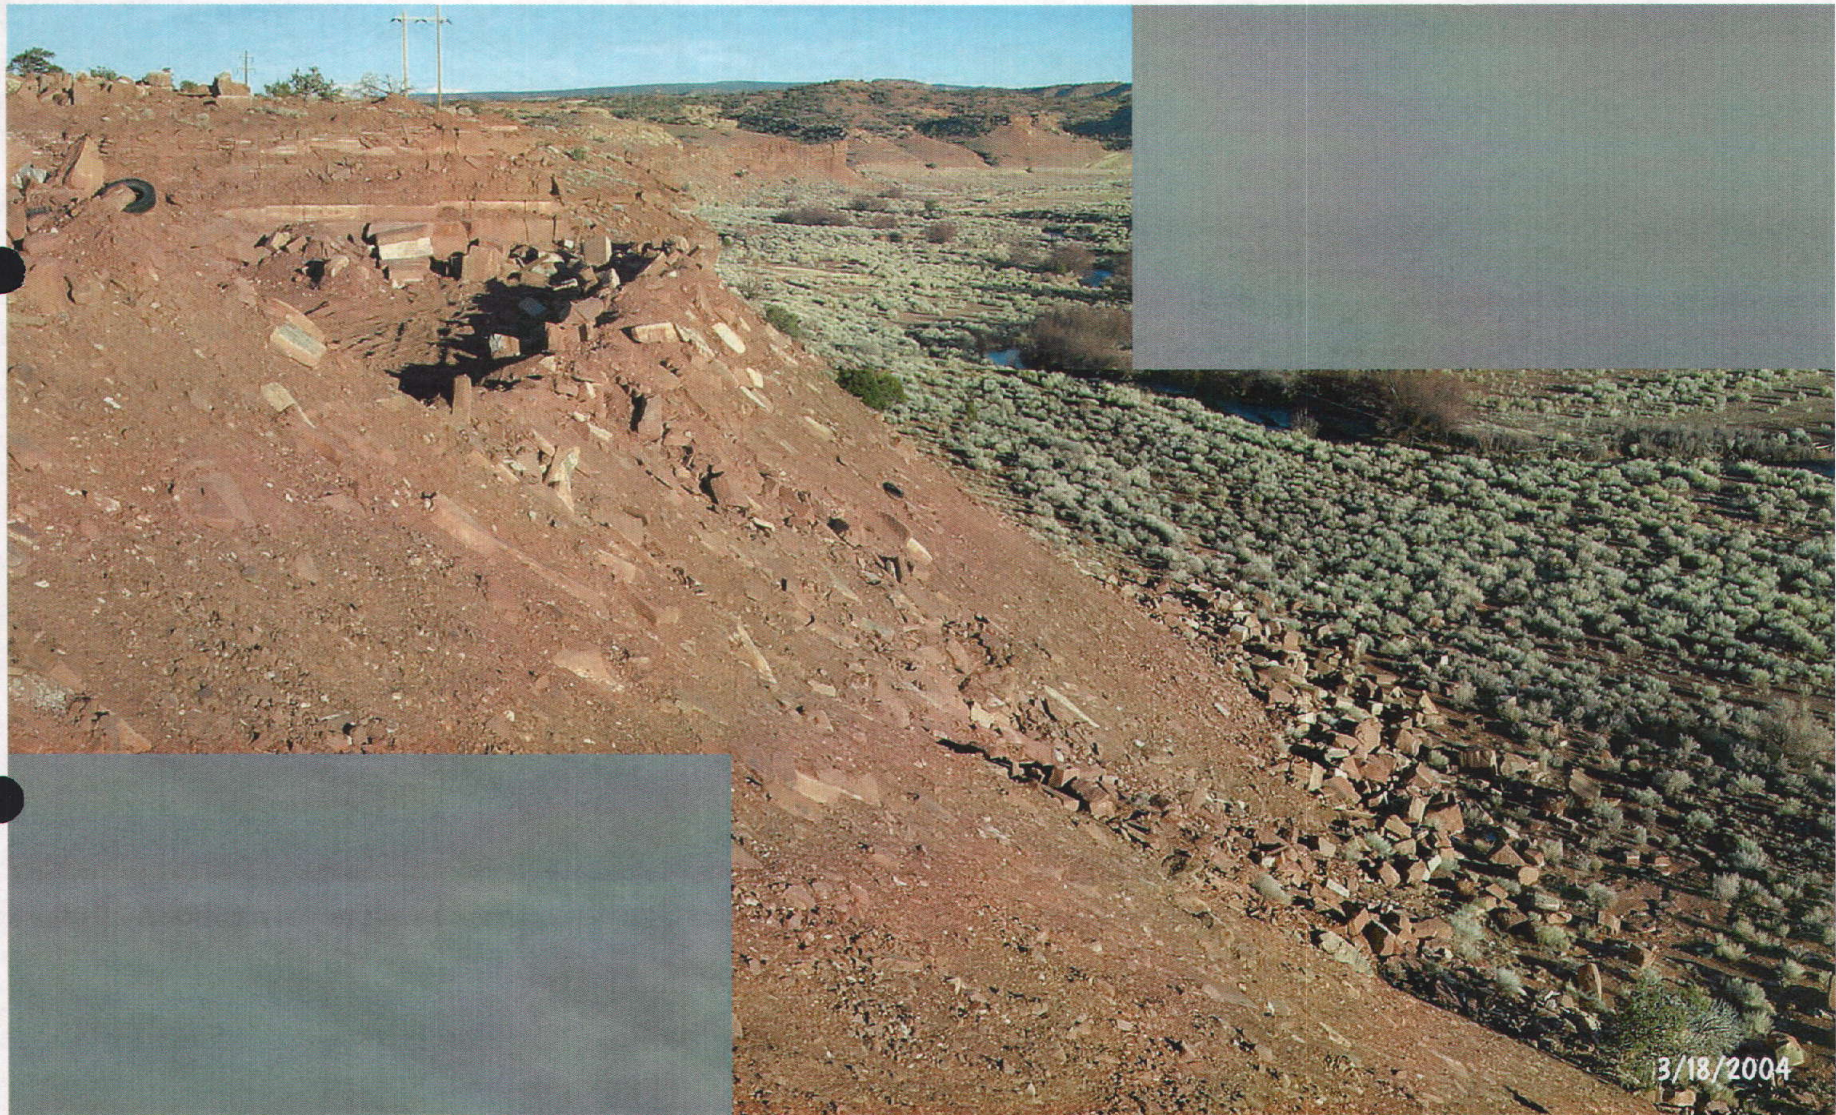
Photo 8. This is where the overburden outslope extends to the valley floor and is just to the east of the area shown in Photo 6.
